Punched Holes in Powder Coated Steel

Your Enclosure Source[®]

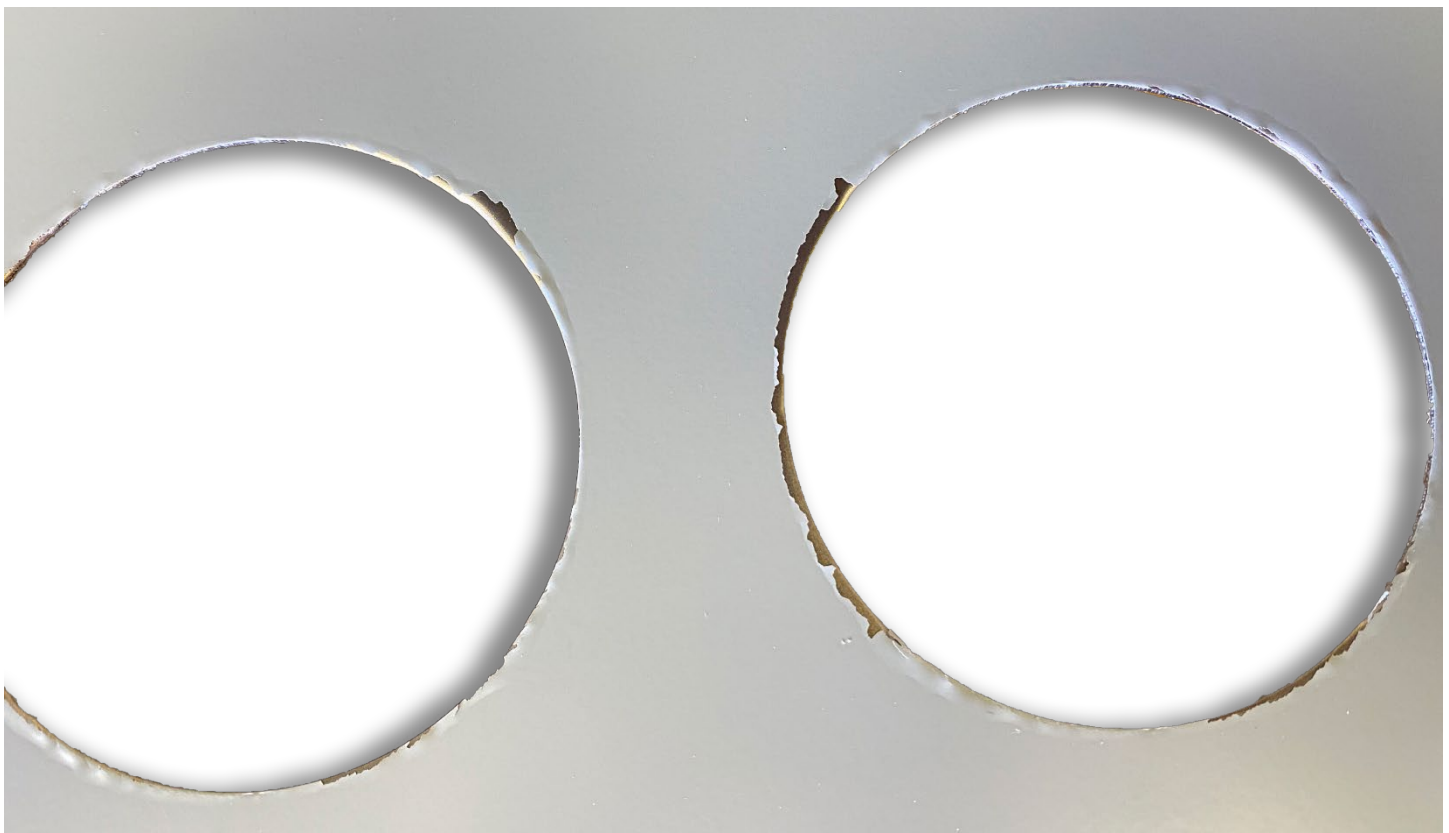
Saginaw Control and Engineering is committed to making sure parts and test panels are found to have 100% adhesion to the steel surface and the coating on our products past the stressed point of the steel. Issues, such as what is shown in the image on the bottom of the page, are found by exceeding the stress point caused from the material stretch and displacement caused from the punch process of an already coated part.

When a hole is punched with a tool such as a Green-Lee punch, the material undergoes a transduce amount of stress bending and stretching the material as it is pulled through the material.

Steel enclosures and accessories are manufactured from commercial grade (CS or CQ.) This steel is ductile enough to be bent flat on itself in any direction in a standard bending process, but also allows considerable amount of material stretch.

In contrast, the applied polyurethane powder coat is much harder than steel and will allow for a degree of bending but does not stretch.

There are some things that can increase the stress failure point:

- The thinner the steel is the easier it is to stretch while punching.
- Variations in steel tensile strength.
- Variations in coating thickness. – The thicker the coating is, the less ability to bend.
- The combination could possibly increase the potential.

There is no way to control or prevent these factors.
